Appendix B

Photographs

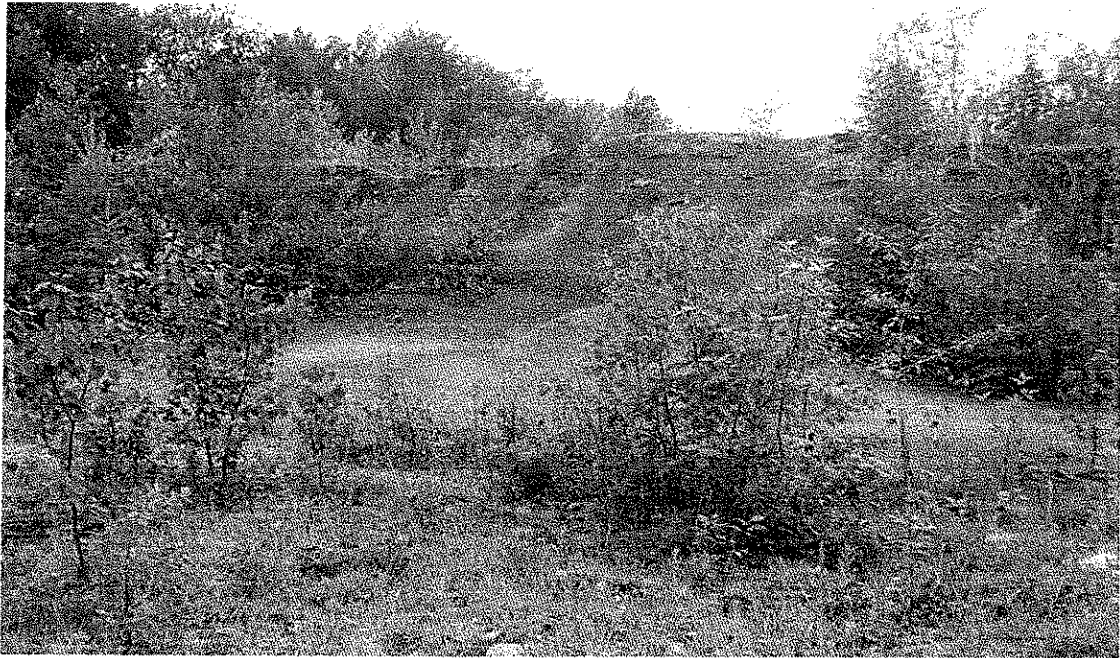
Photograph 27 – June 2006 by Curtis Dungey

Description: Iron concentrate storage stockpile located south of the mill buildings.

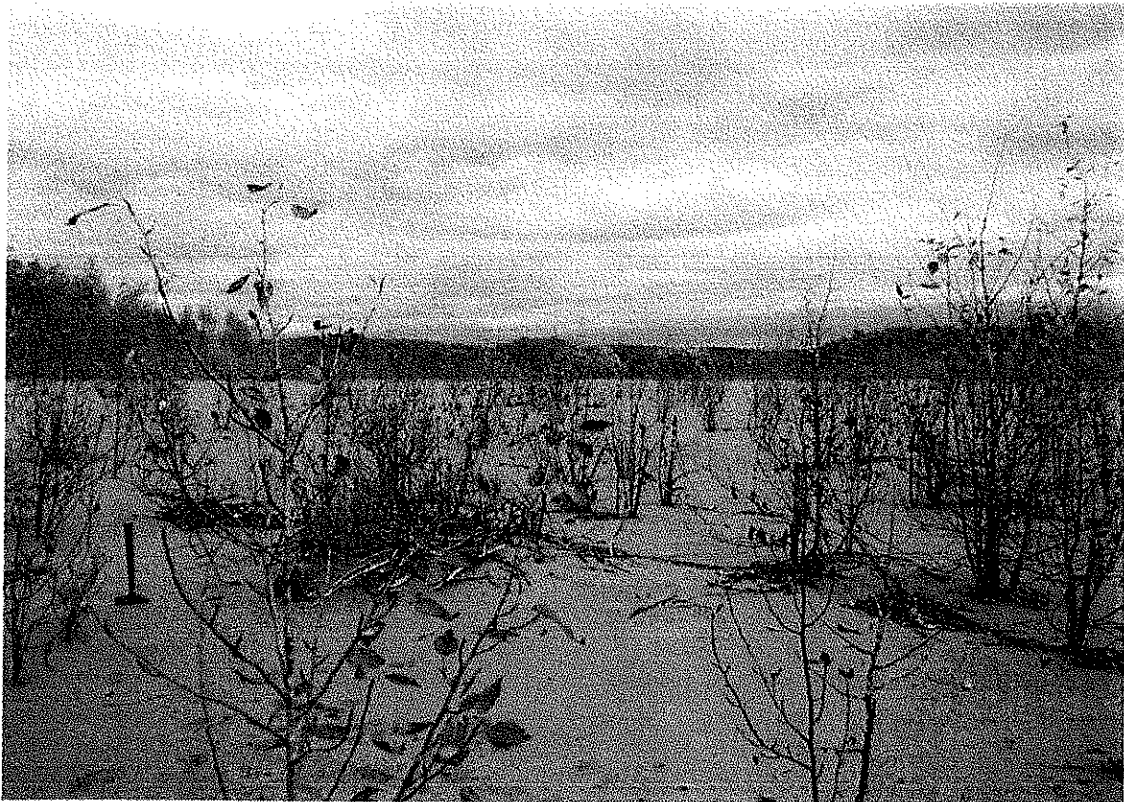
Photograph 28 – September 2006 by Jeff Lynott

Description: Iron ore tailings storage area located east of the mill buildings.

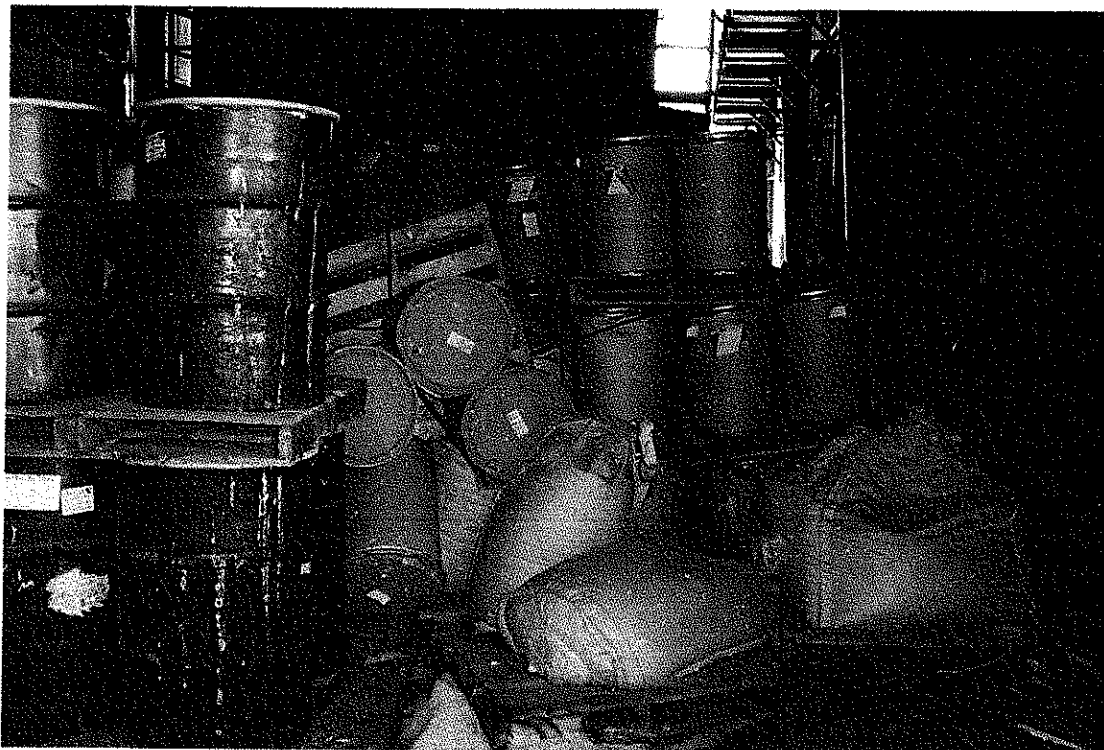
Photograph 29 – March 2006 by Scott Janssen

Description: Drums and supersacks stored in west end crusher building.

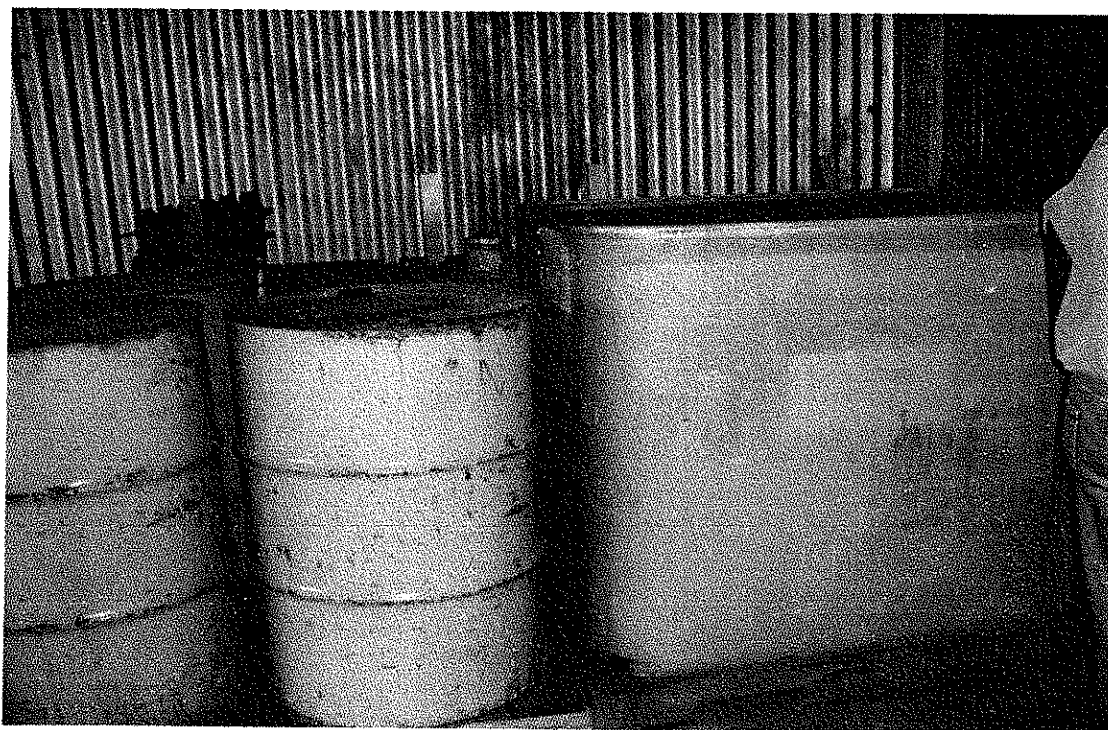
Photograph 30 – June 2006 by Curtis Dungey

Description: Drums of mill reagents in west end of maintenance shop.

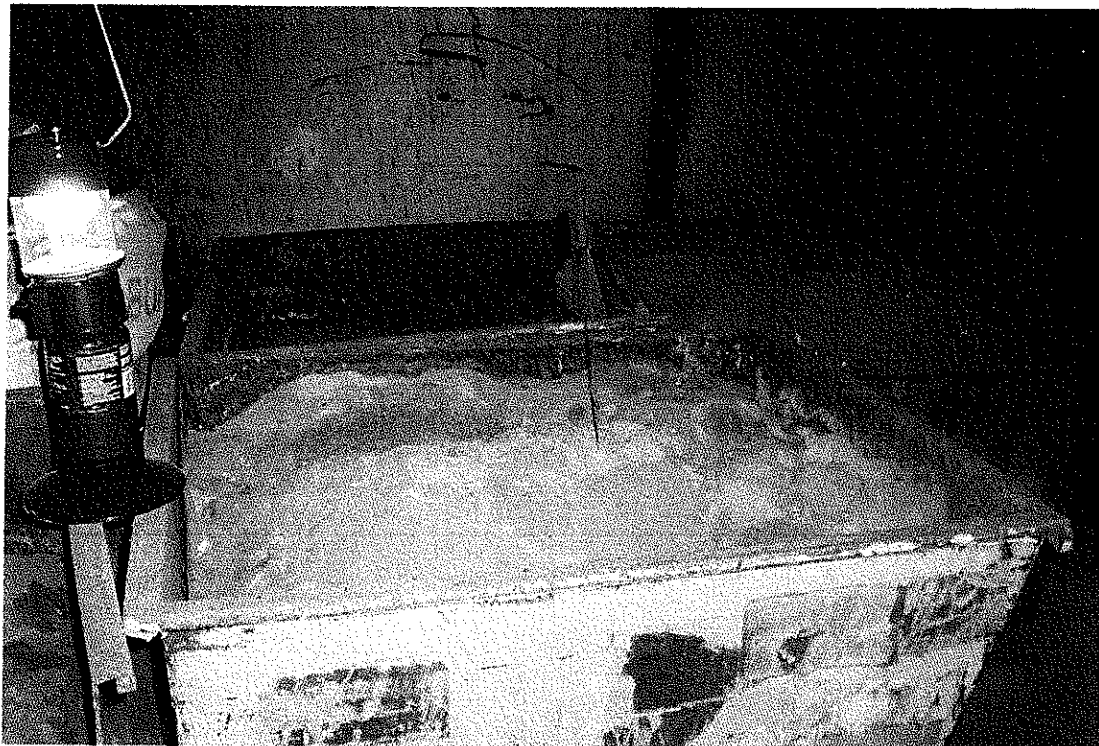
Photograph 31 – March 2006 by Scott Janssen

Description: Main mill basement floor metal tubs of residual material.

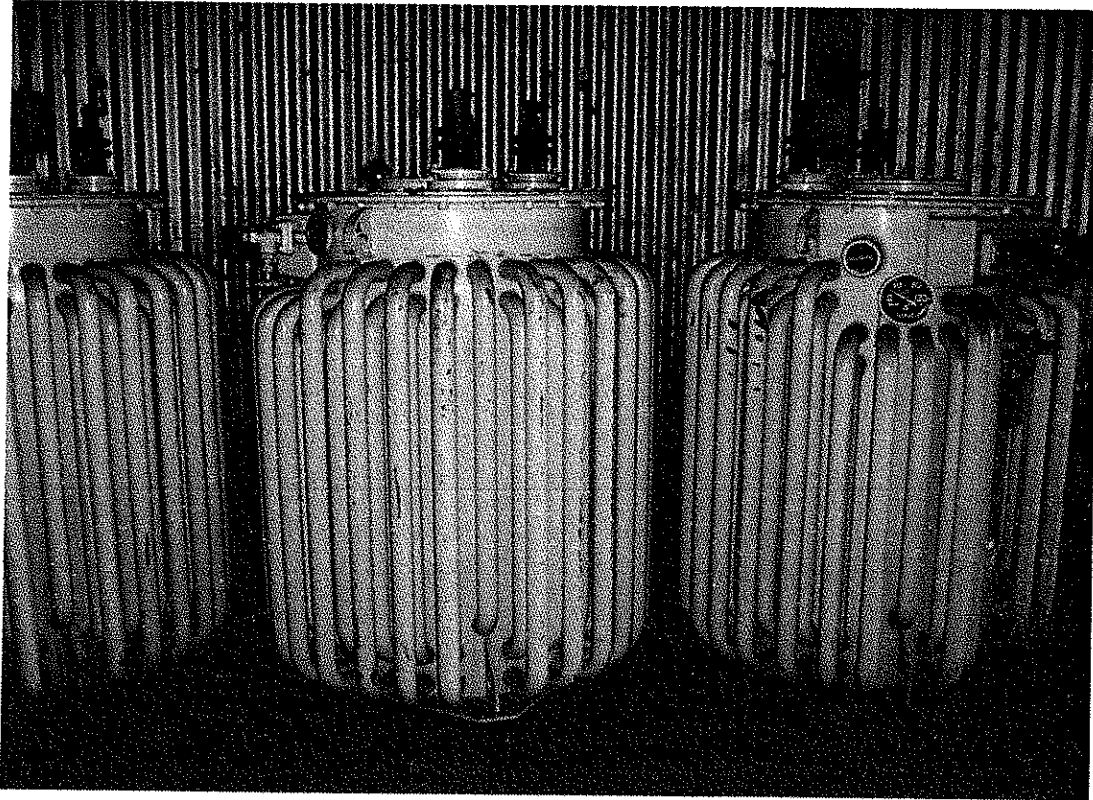
Photograph 33 – June 2006 by Curtis Dungey

Description: Old transformers.
